TECHNICAL INSPECTION REPORT

OPERATION CROSSROADS. U.S.S. INDEPENDENCE (CVL 22)

TEST ABLE.

VOLUME 2 OF 4 [10]

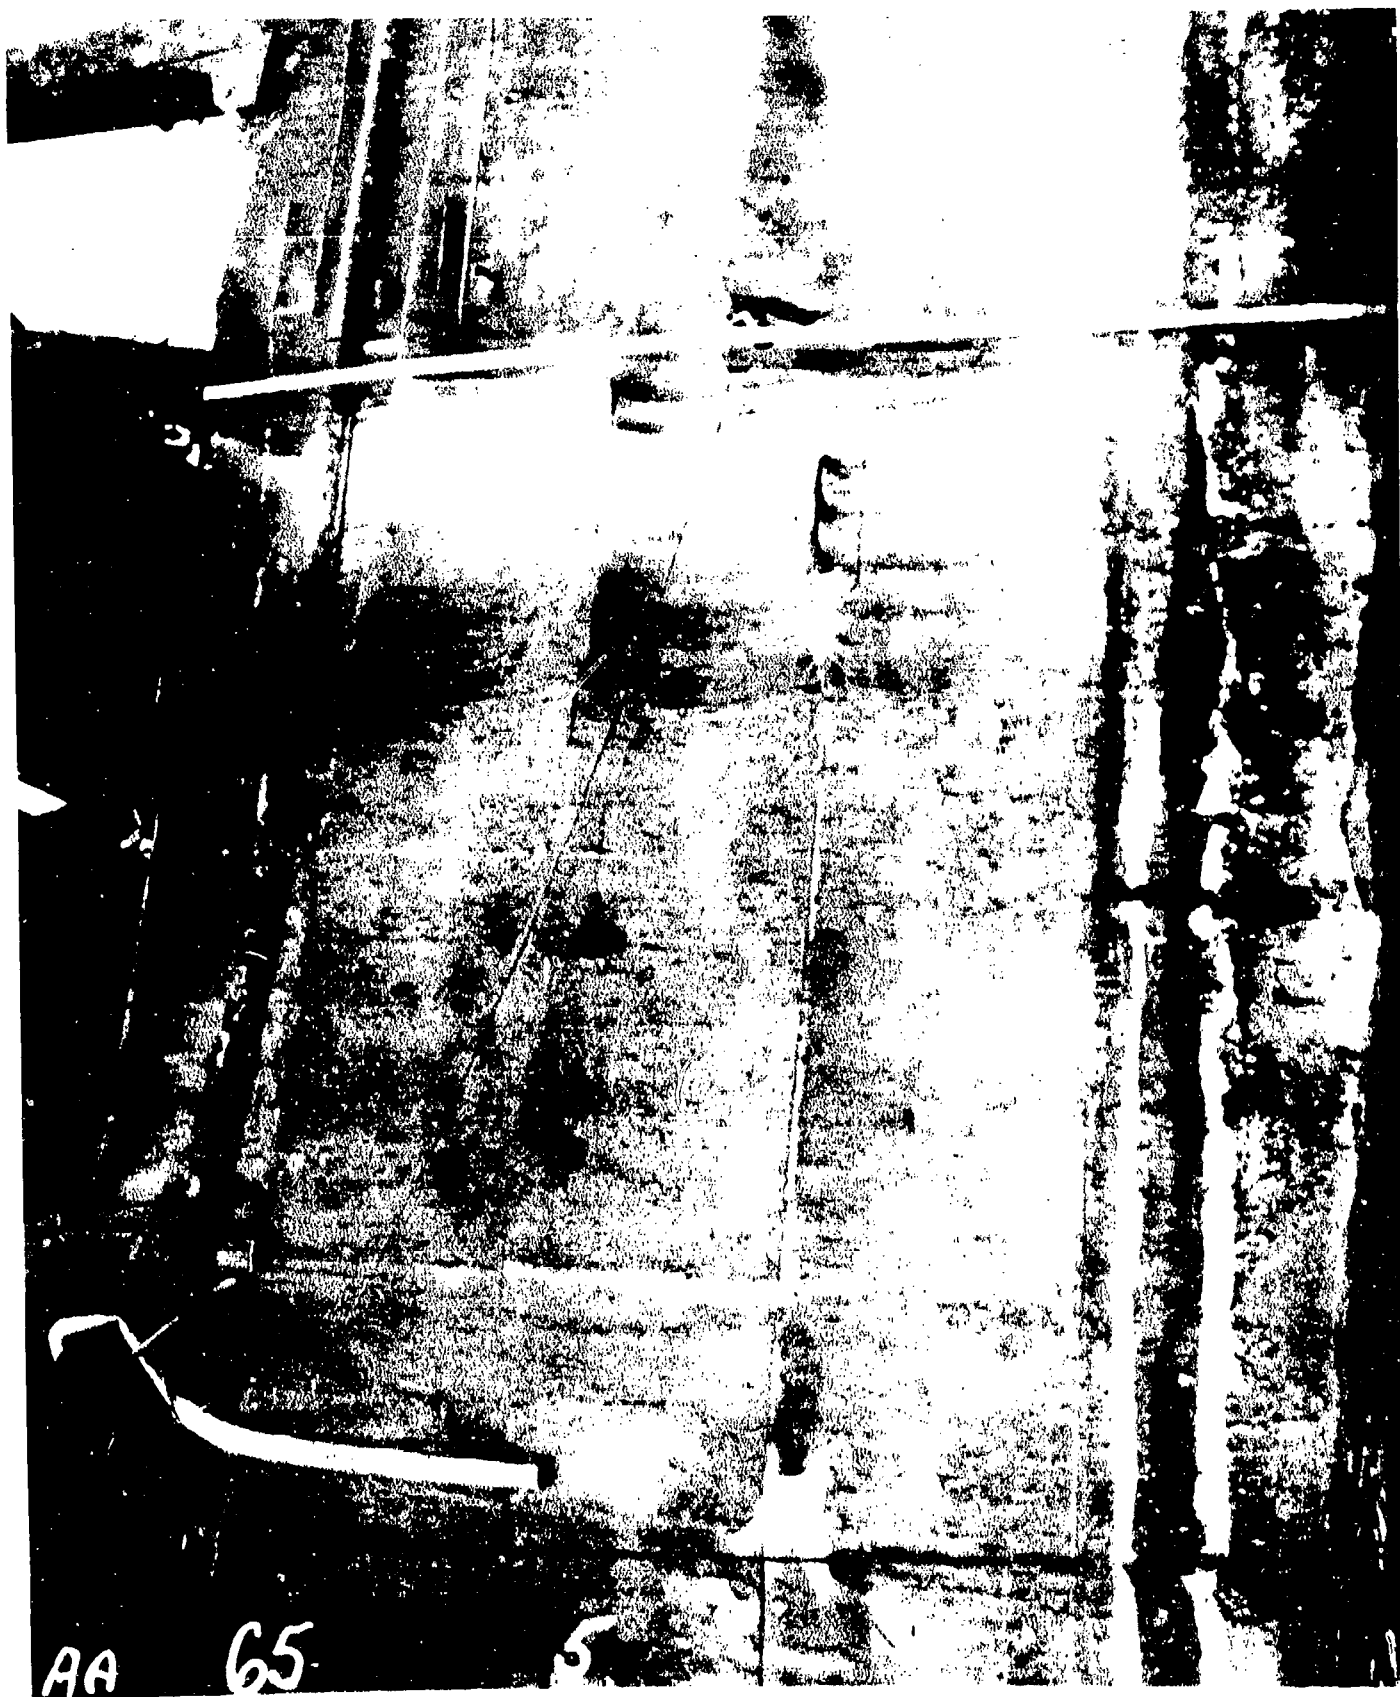
AA-CR-65-1734-5. Detail view of port shell between frames 106 and 116. Note sharp depression under Wobble Bent at frame 110, tear along weld at stringer at frame 113, and general washboard appearance of shell.

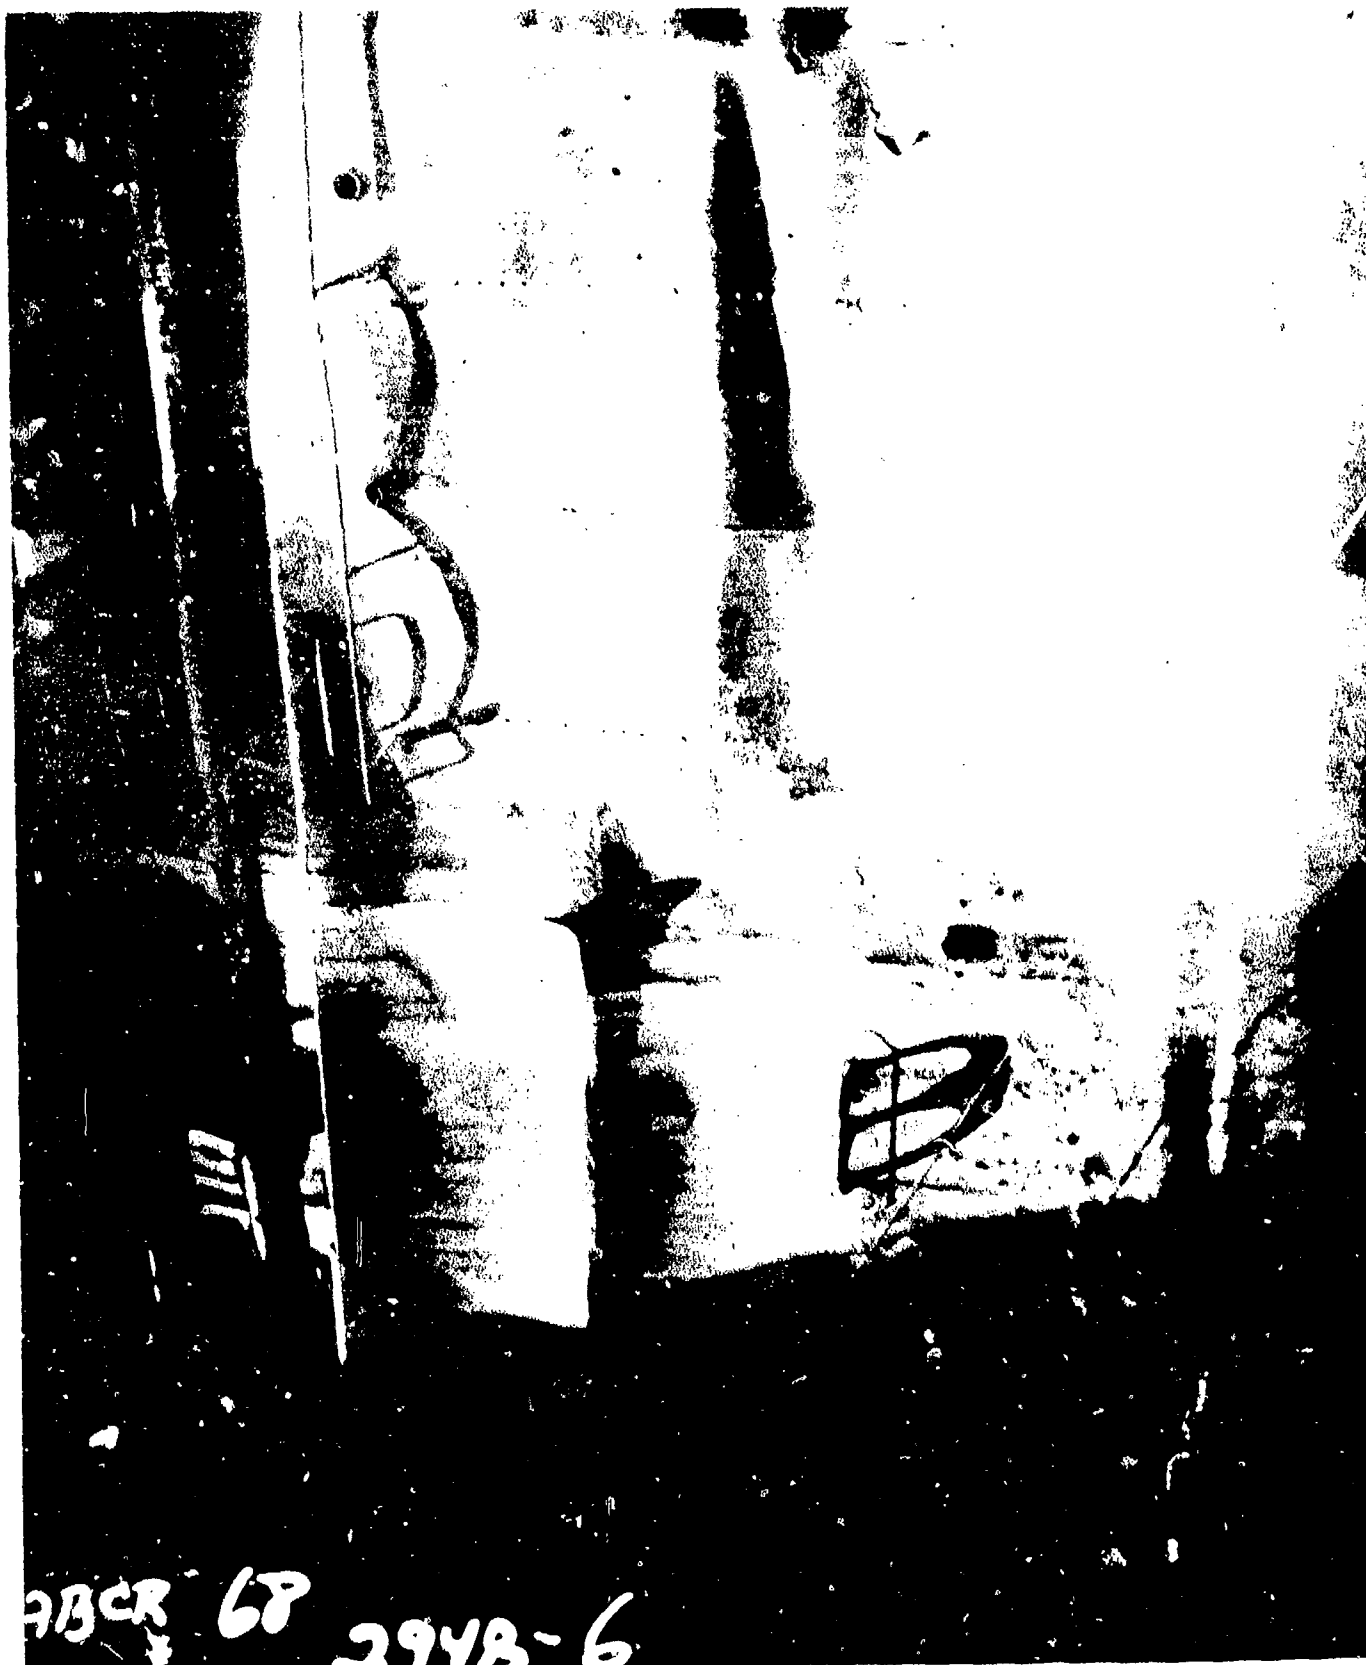
AB-CR-68-2948-6. After Baker. Detail view of port side, frames 108-115.

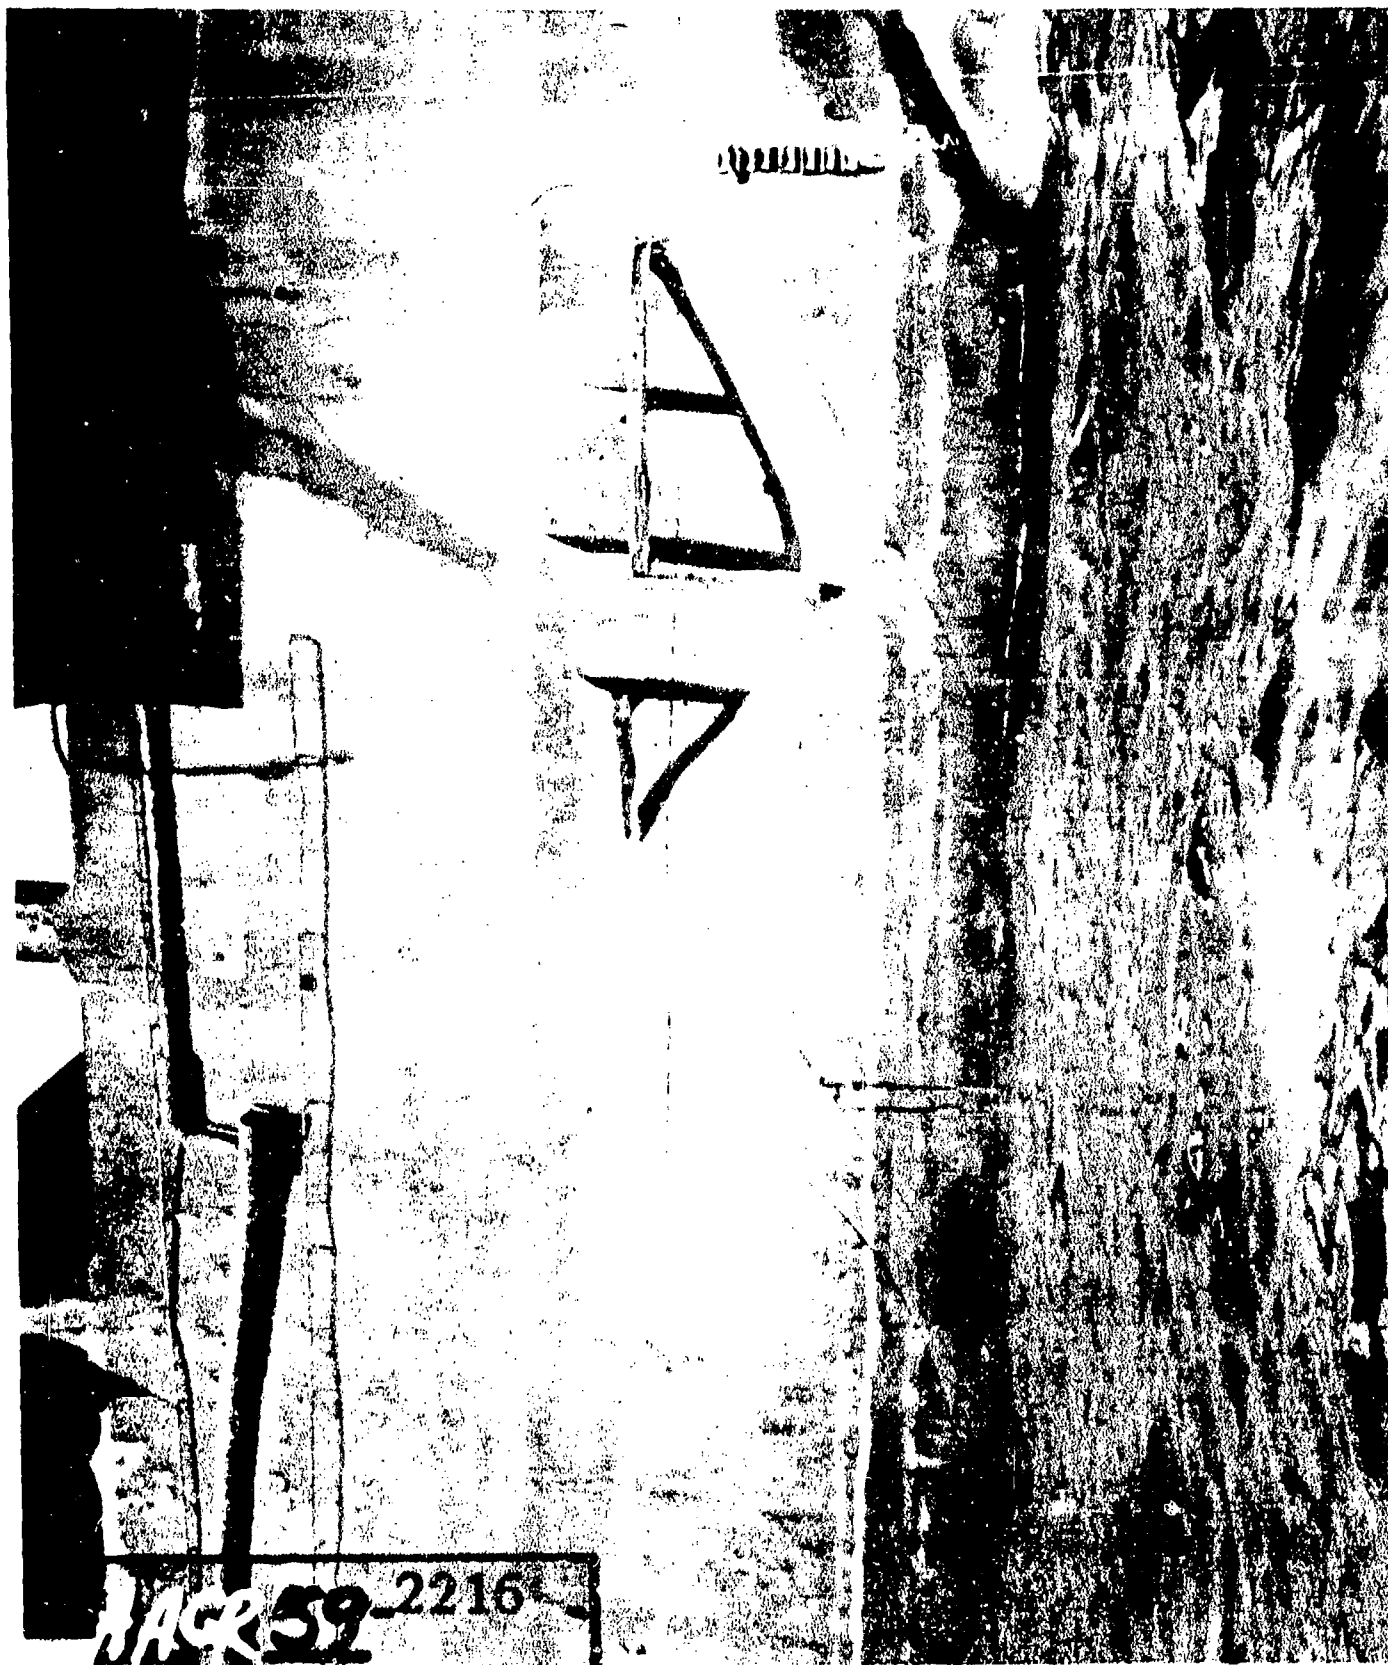
AA-CR-59-2216-4. Detail view of port shell between frames 115 and 128. Note deep depression below third deck and aft of frame 126.

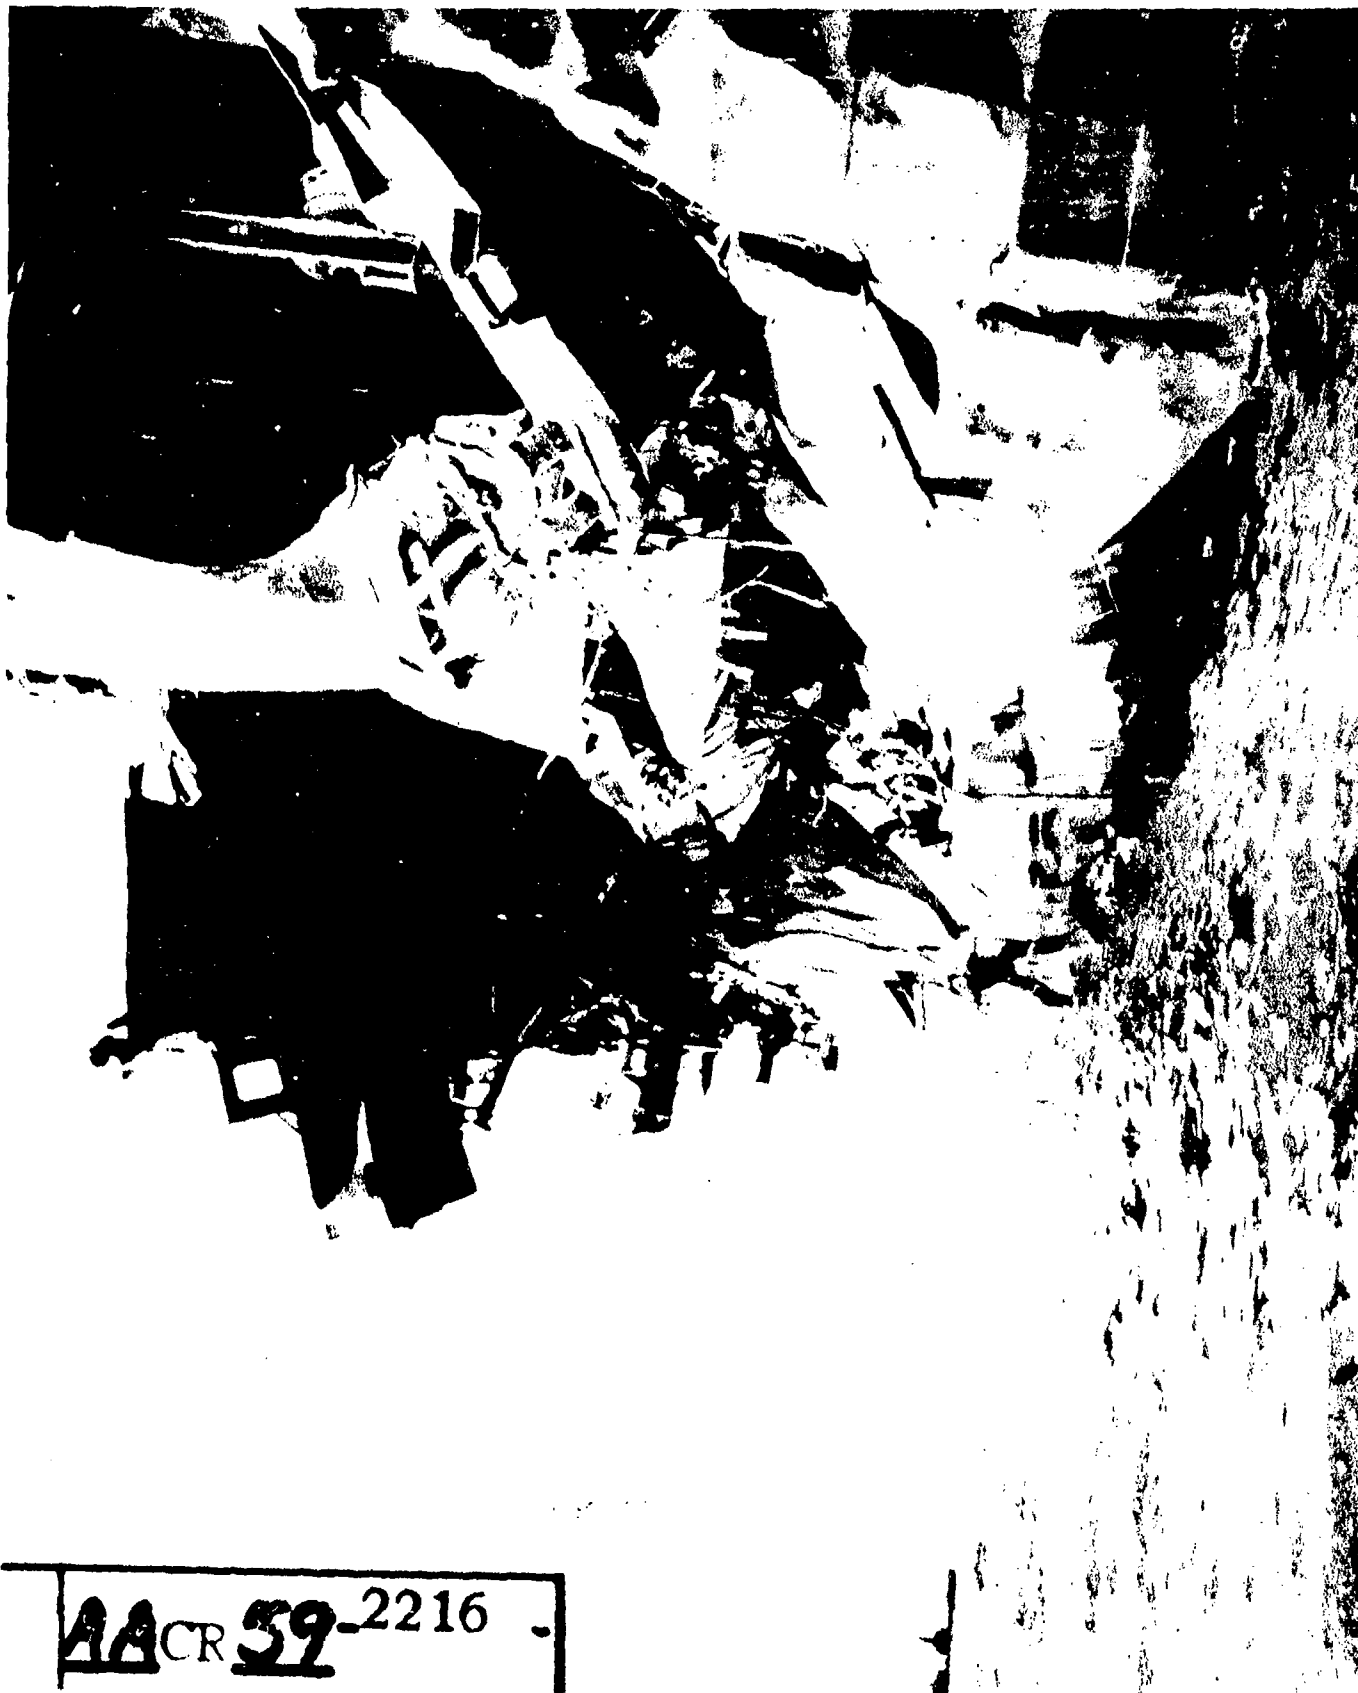
AA CR 59-2216

AA-CR-59-2216-12. General view of port after quarter. Note twisting of lower port after corner of transom.

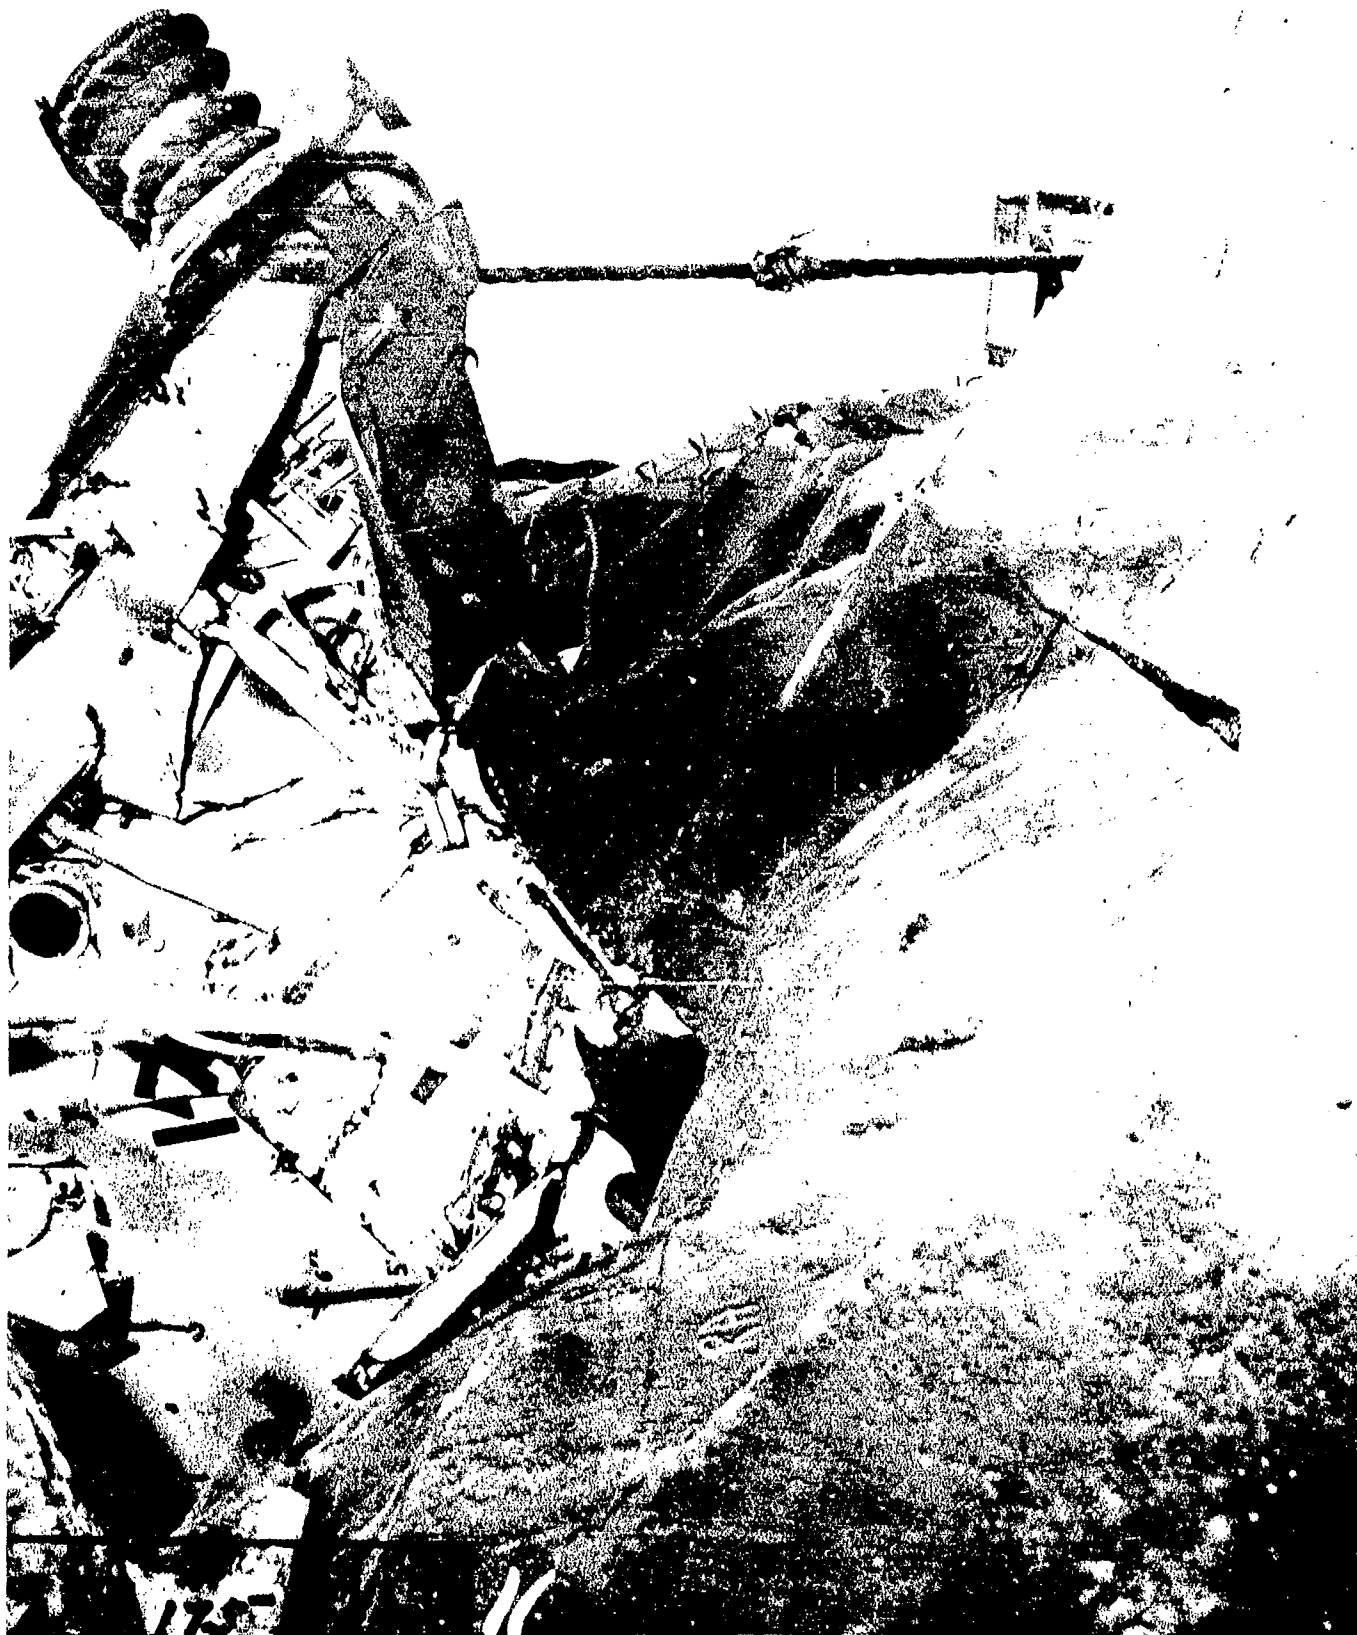
AA-CR-175-2117-11. Port shell, frames 144 and aft, second deck level, showing tear in welded seam.

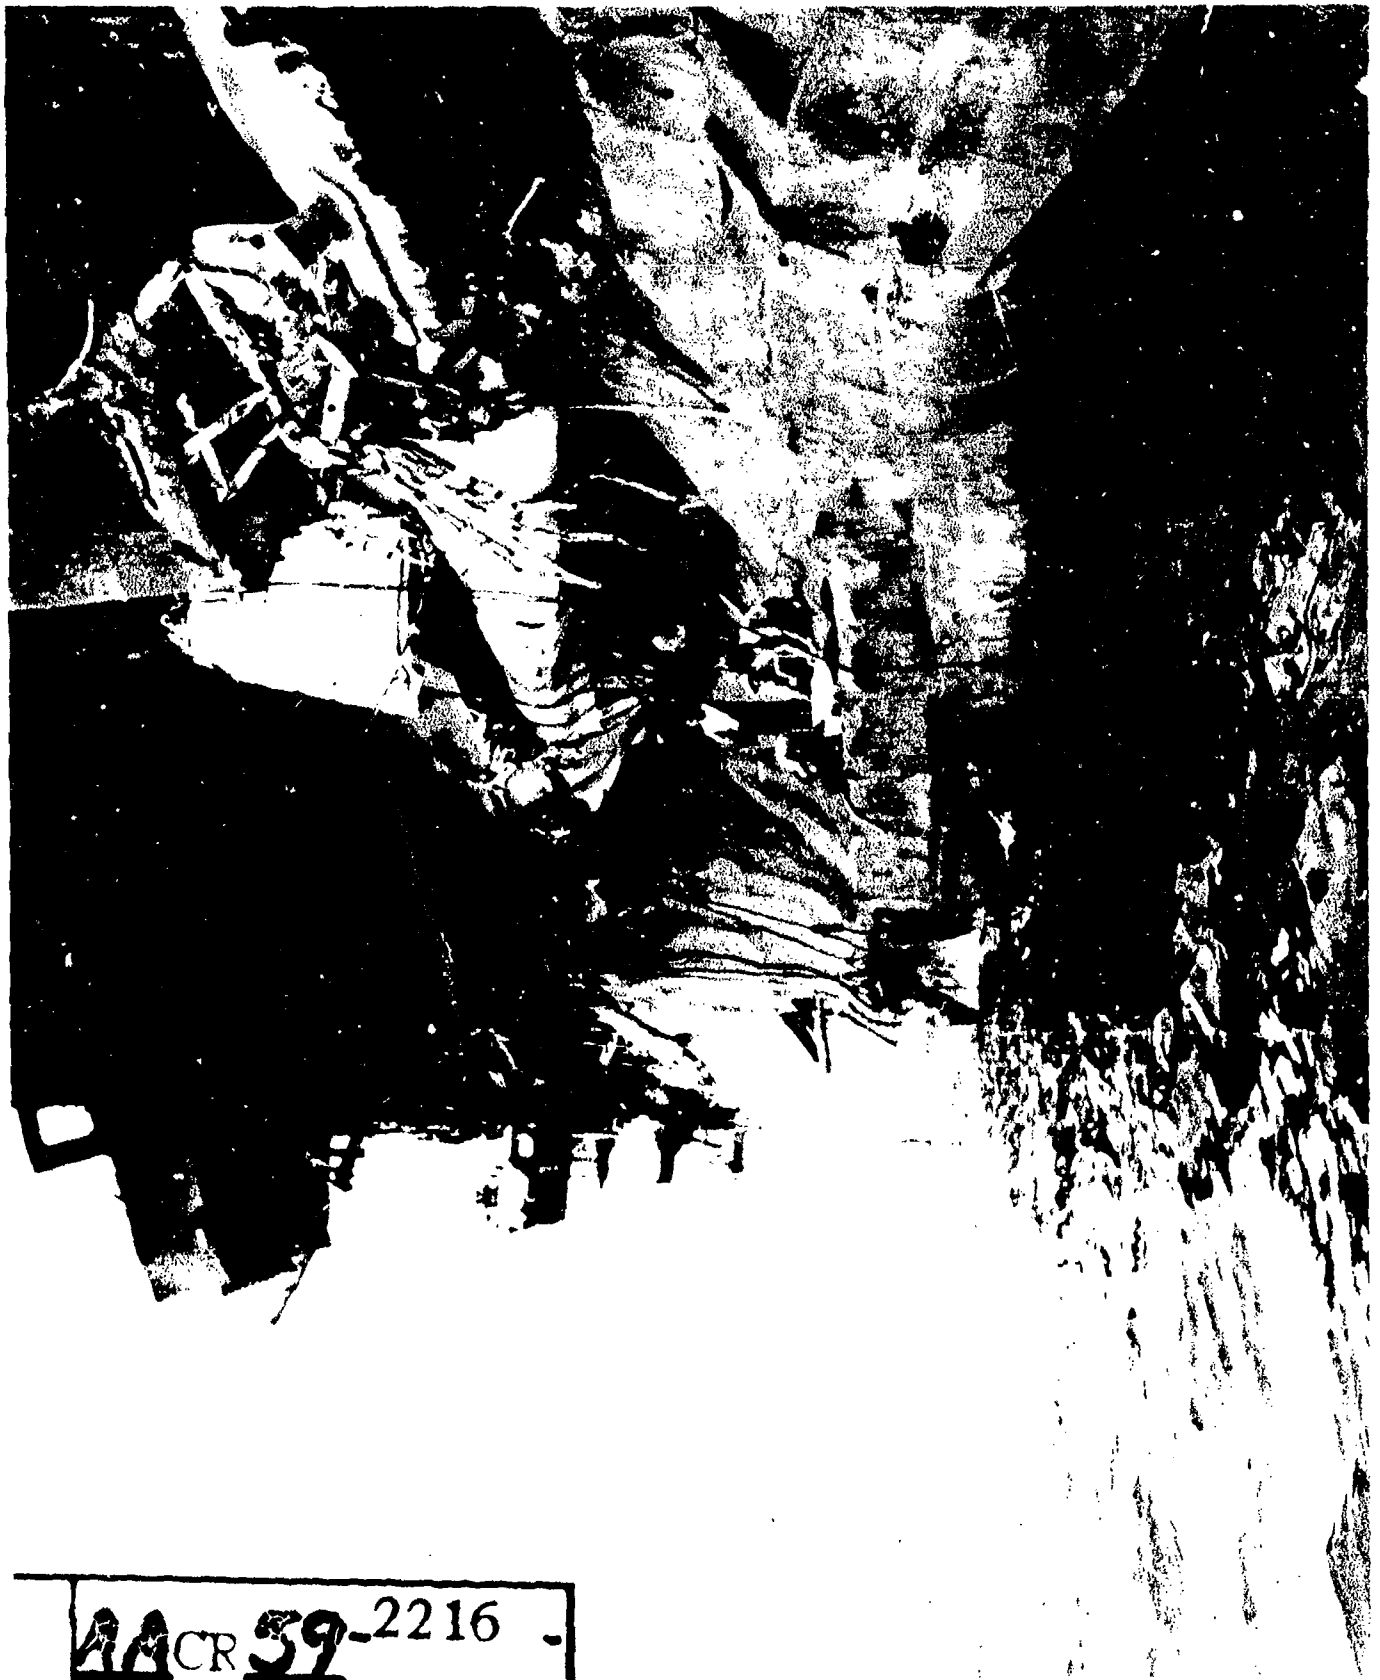
AA CR 59-2216 .

AA-CR-59-2216-9. Detail view of port after quarter.

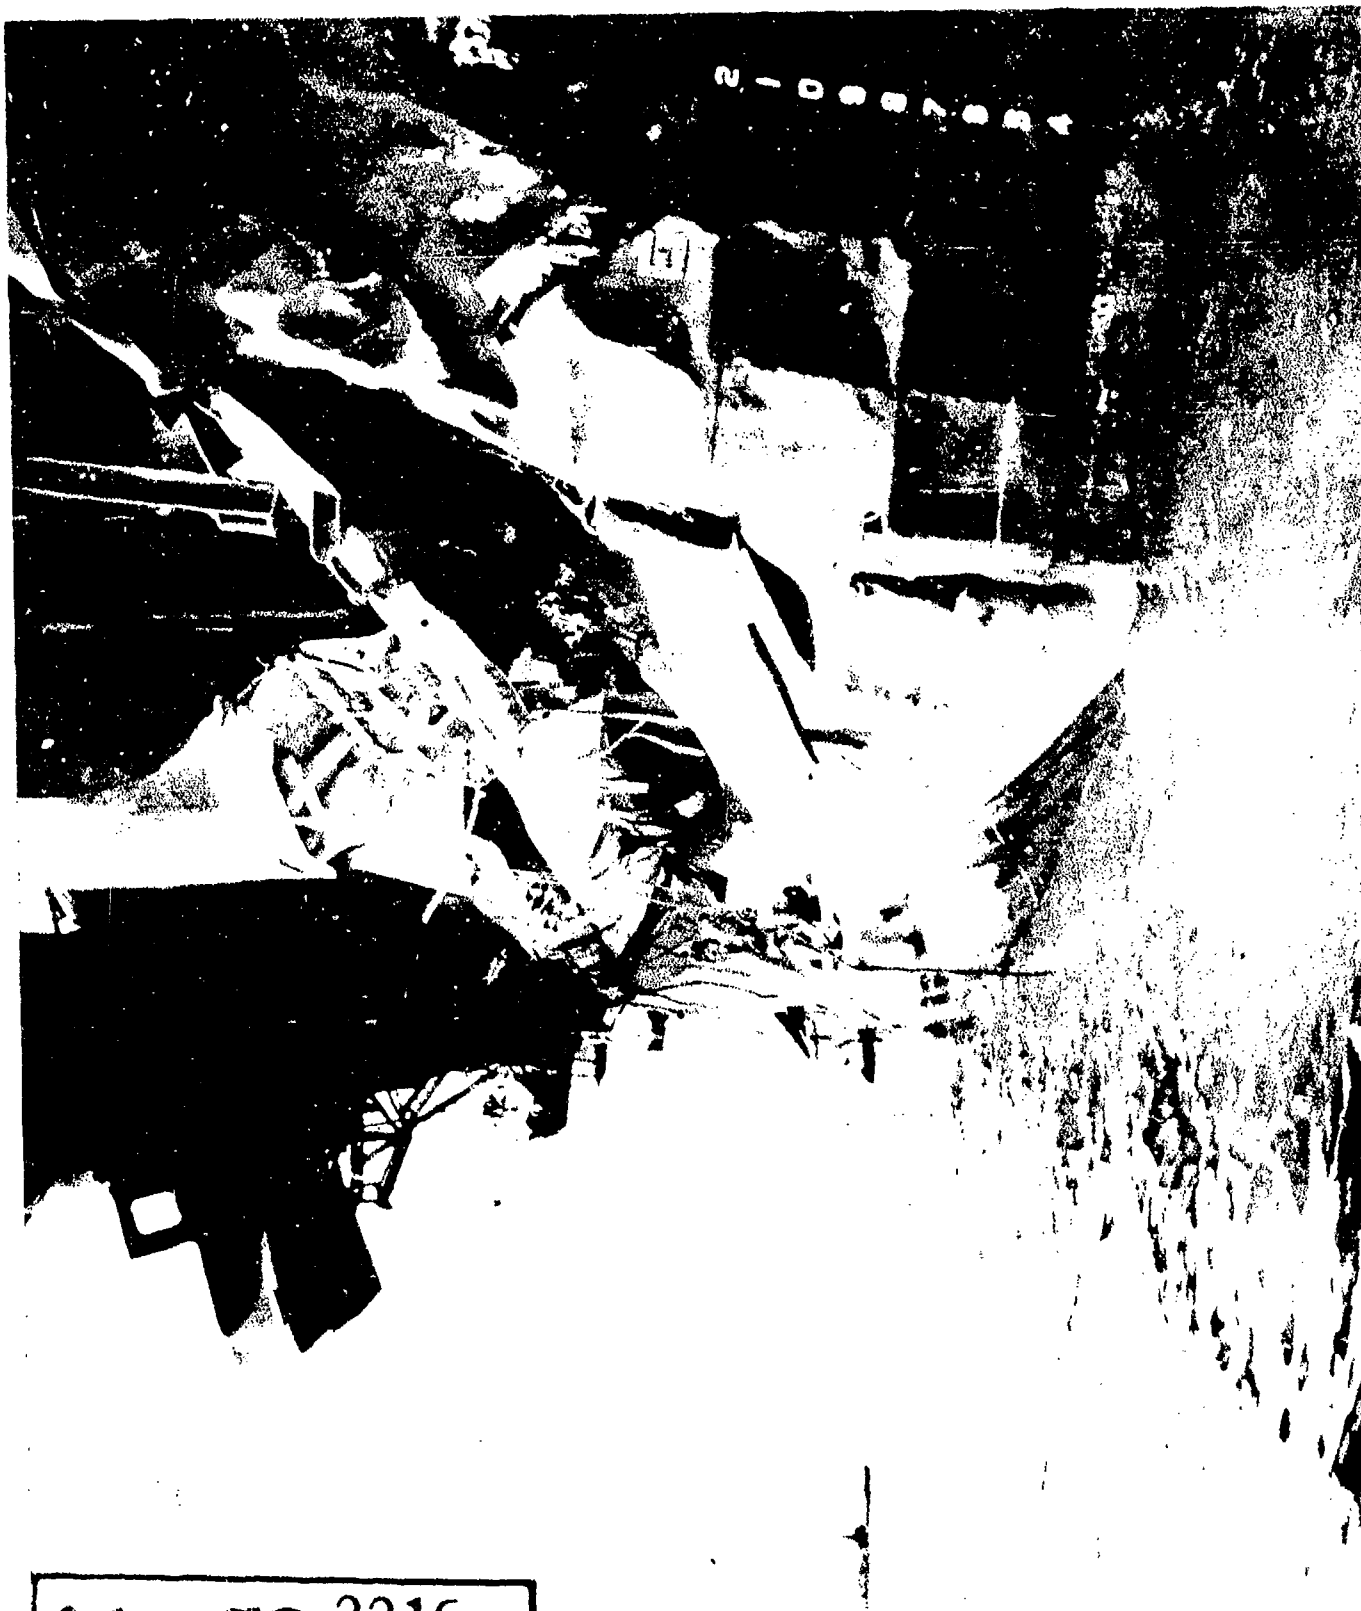
AA CR 59-2216 -

AA-CR-59-2216-11. View at stern, looking forward along port side. Note portion of main deck between frames 144 and 146 still connected to side plating. Top and bottom seams of aft gun sponson are opened. Main deck is folded downward and inward.

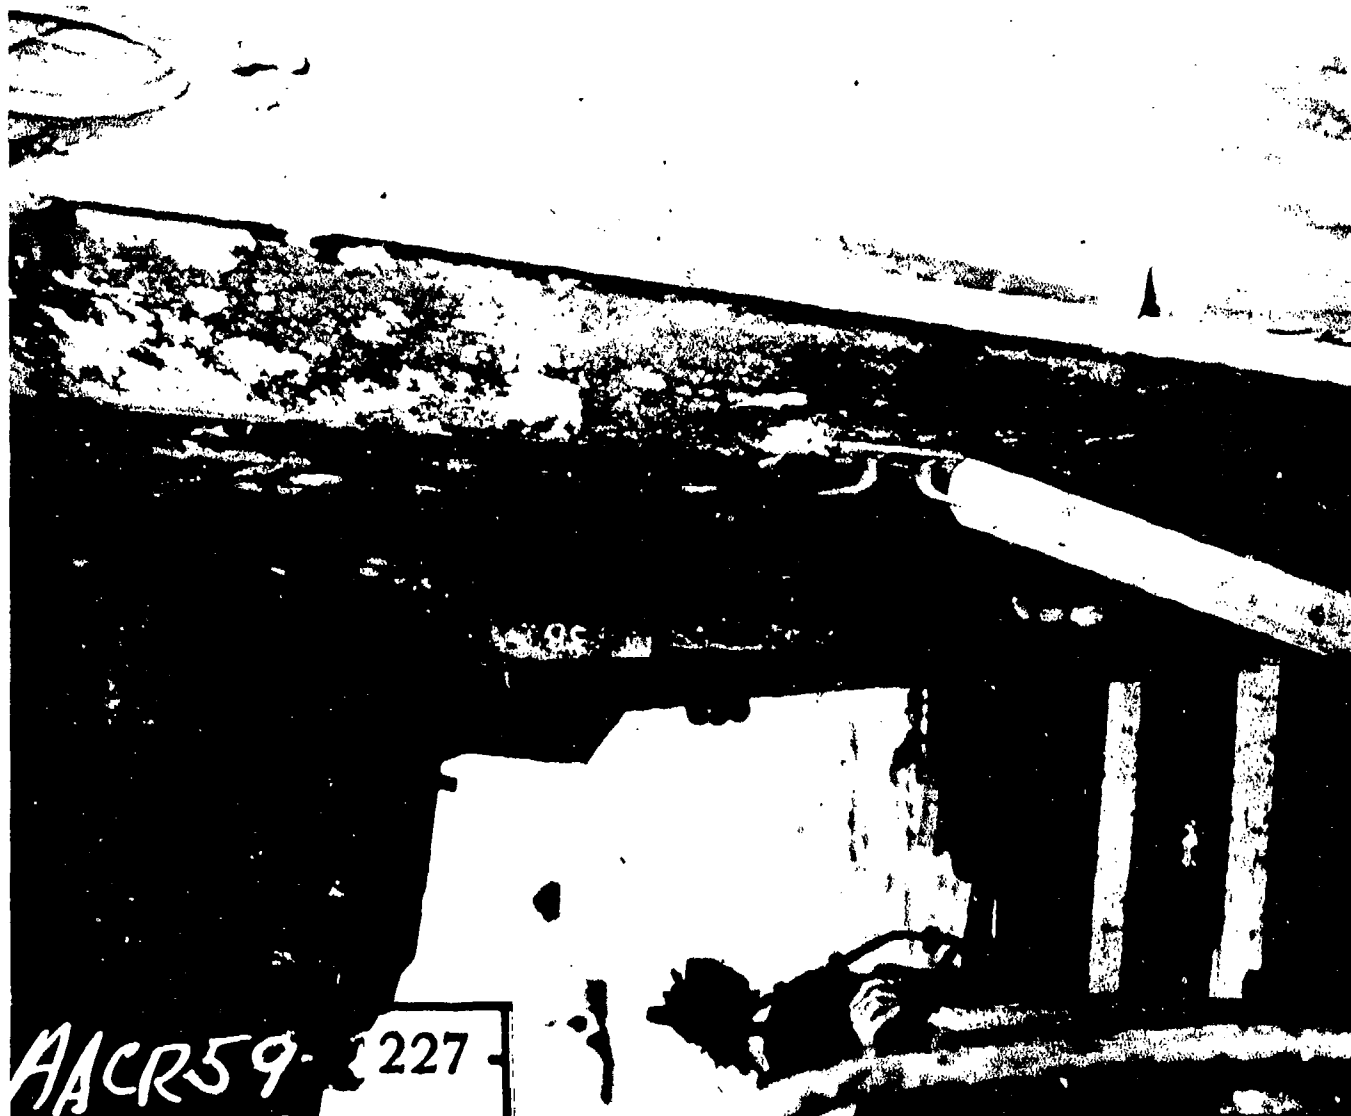
AA-CR-59-2227-8. Looking forward from frame 45 along port shell above forecastle deck showing dished door panel and scarred paint not caused by fire.

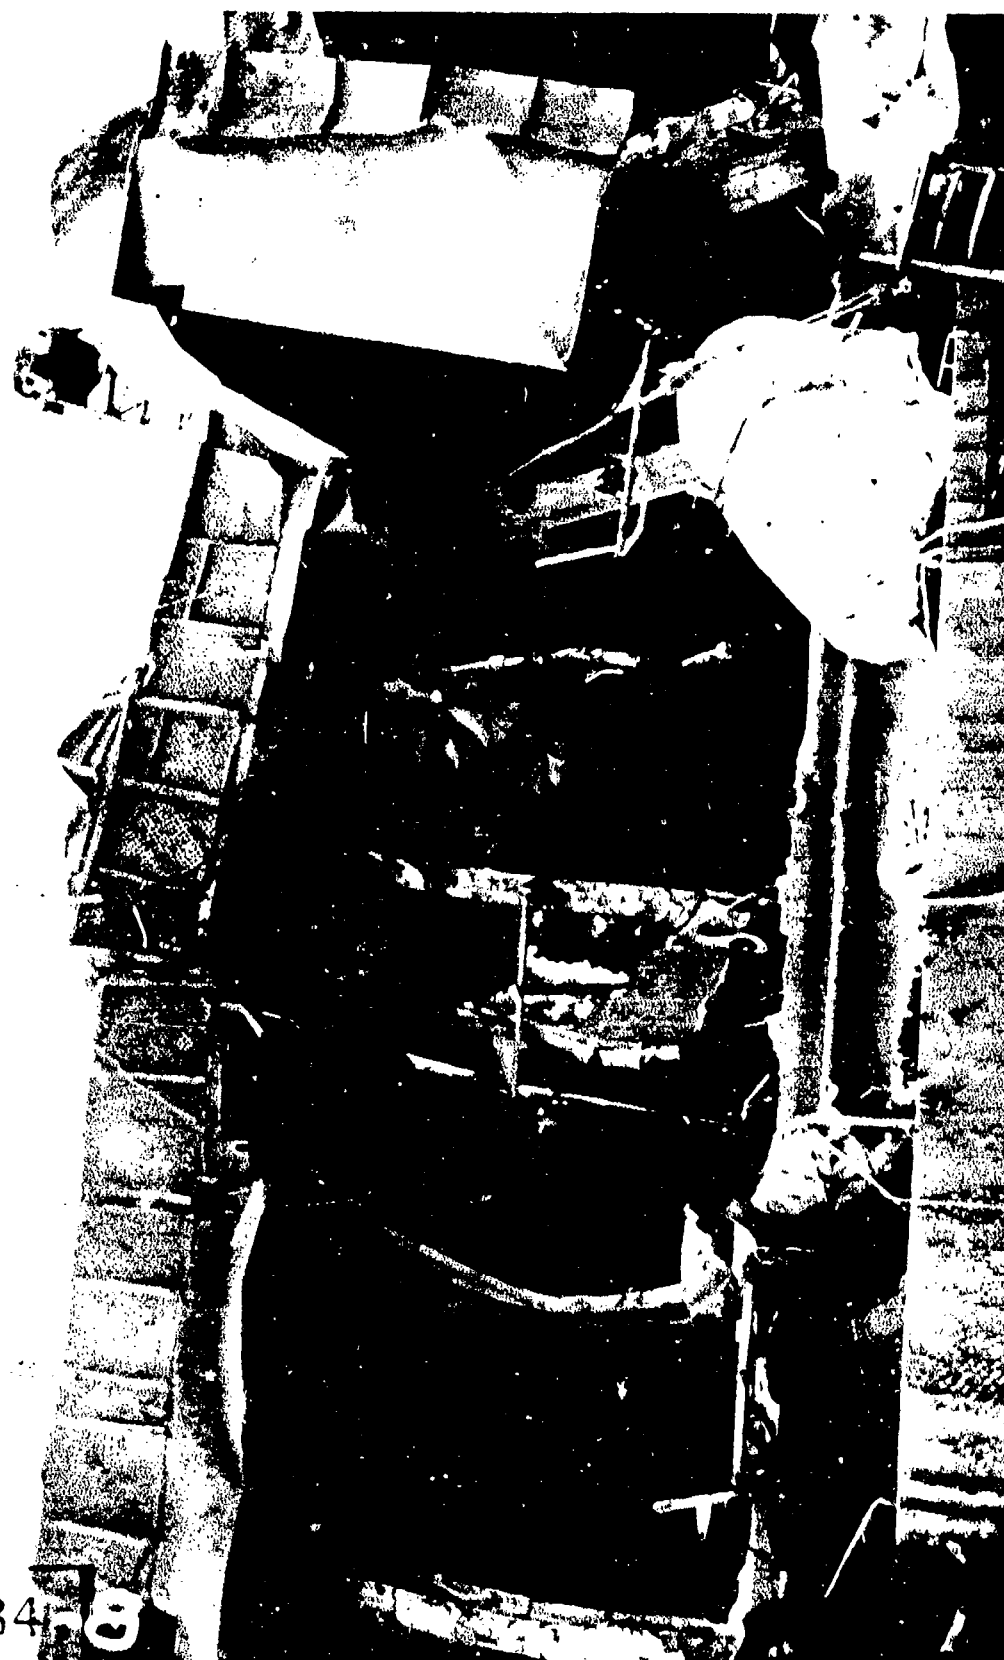
1 (T) 65 - 1734-8

AA-CR-65-1734-8. Damaged flight deck bents between frames 80 and 95, gallery walkway and spansons. Note opening of expansion joint, frame 84 1/2.

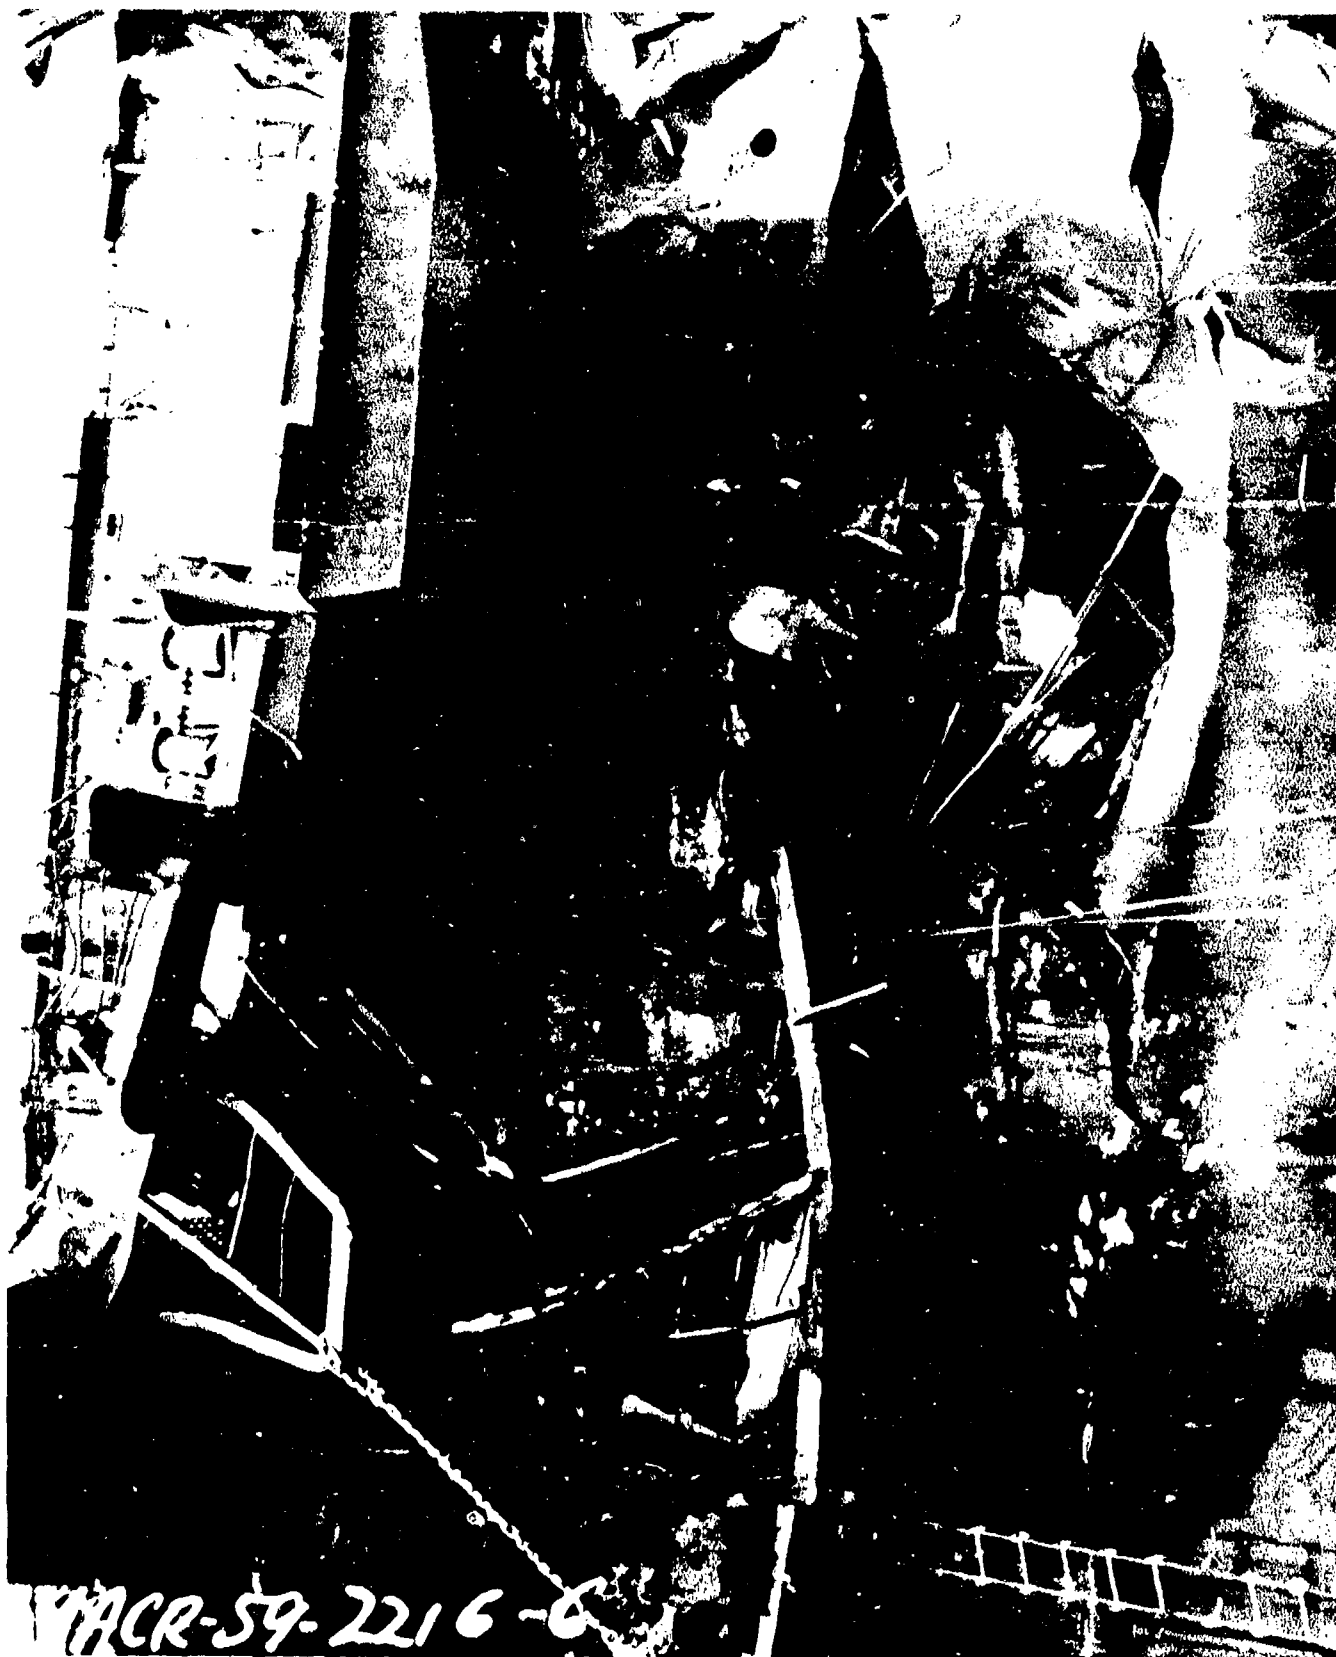
AA-CR-59-2216-6. Tear in port shell above main deck at bulkhead 132, and general disruption of structure between frames 131 and 137.

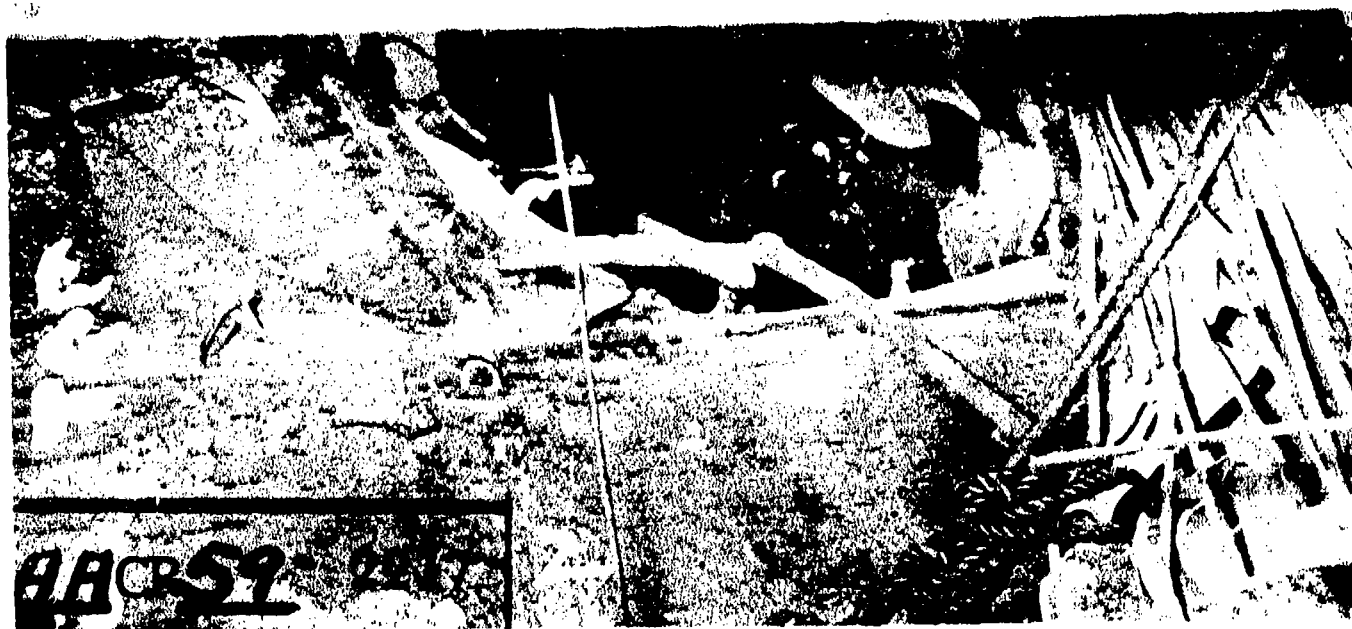
AA-CR-59-2217-2. Port shell aft of bulkhead 132, looking aft and down from hangar level catwalks.
